MICROWAVE ASSOCIATES INC BURLINGTON MA  
RELIABILITY OF HIGH-POWER PULSED IMPATT DIODES. (U)  
NOV 81 M S AYYAGARI, J L HEATON, N JANSEN

## RELIABILITY OF HIGH-POWER PULSED IMPATT DIODES

Microwave Associates, Inc.

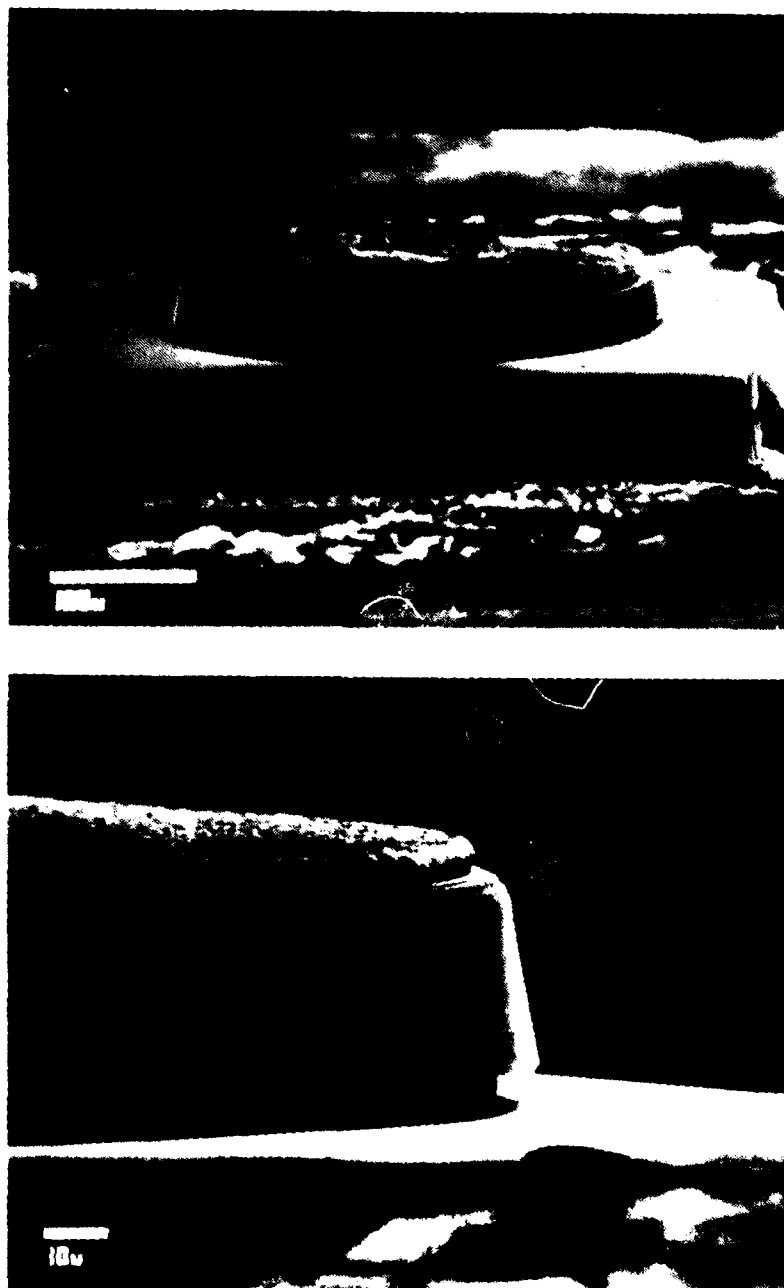
FIGURE 2-6 STRUCTURE OF A SINGLE CHIP PULSED IMPATT DIODE WITH IMPROVED MESA CONSTRUCTION PROCESS

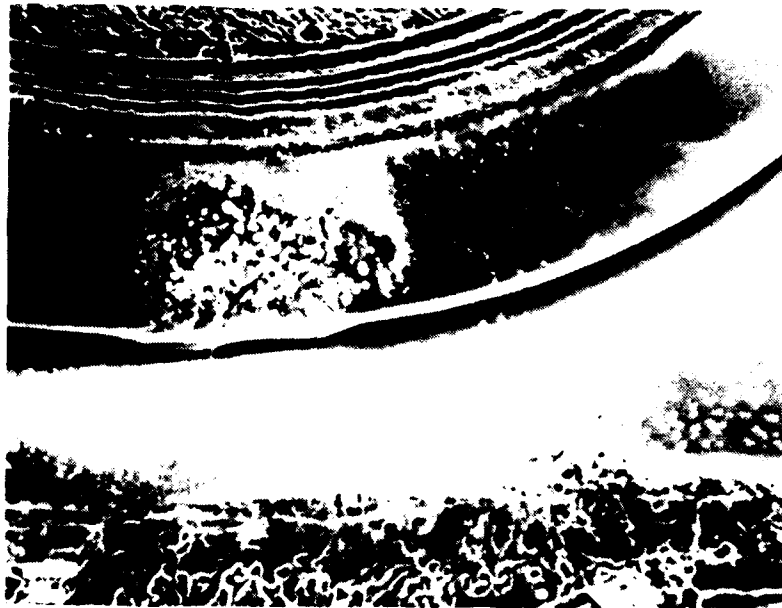
FIGURE 3-5 SIDE VIEW OF A DEVICE FOLLOWING FAILURE  
IN dc BURN-IN

Figure 3-5 shows a typical edge burn-out failure. The extreme heat generated during failure has vaporized the gallium arsenide in the failure region. Such failures may be due to defects or grain boundaries in the substrate which lead to corresponding defects in the epitaxy (see Figure 3-6) or lot spot formation due to poor bonding. Although the center of the mesa would be expected to experience the higher temperature, edge burn-out would be expected because of the higher electric field in the area of any irregularities in mesa shape.

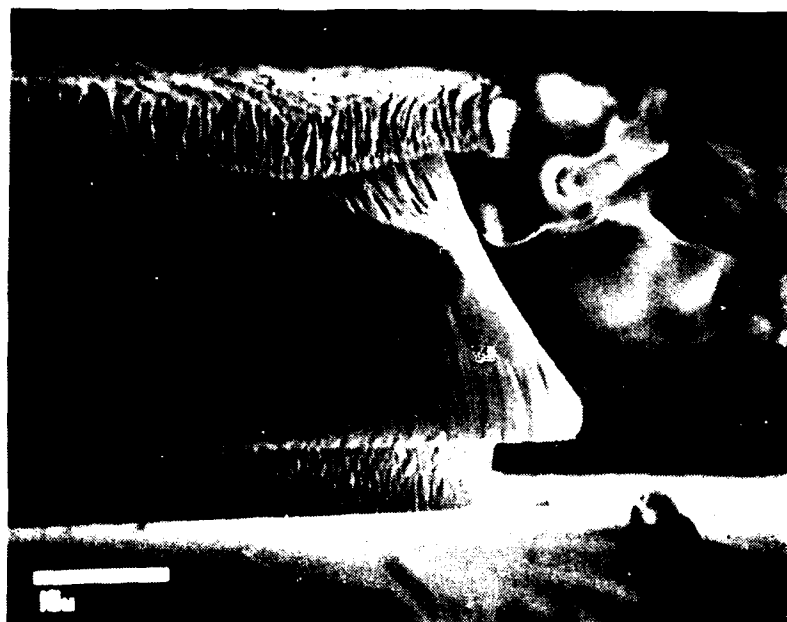
FIGURE 3-6 SIDE VIEW OF A DEVICE EXHIBITING IRREGULAR ETCHING IN THE SUBSTRATE REGION

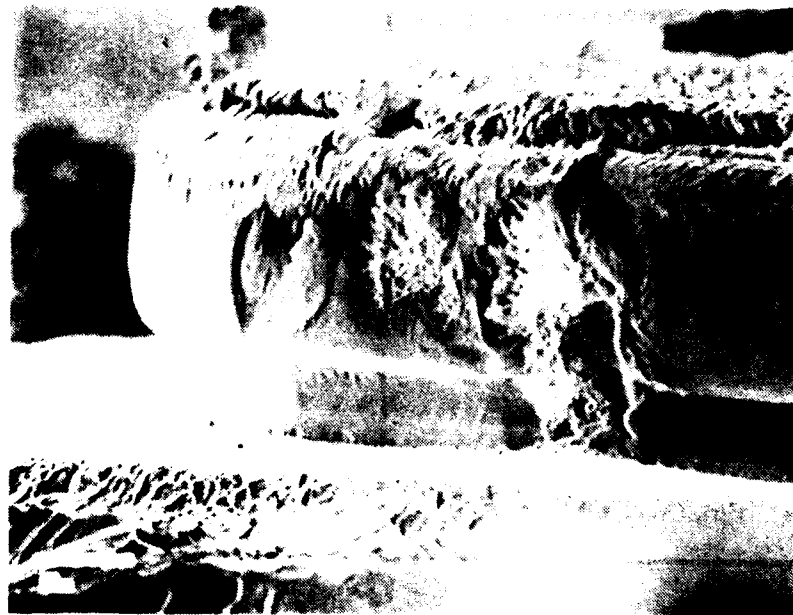
**FIGURE 4-8 TWO VIEWS OF A LH-LHL DOUBLE DRIFT DEVICE FOLLOWING FAILURE AFTER 809 HOURS OF PULSED RF BURN-IN AT 265°C JUNCTION TEMPERATURE**

Although edge failures were found (see Figure 4-8), more devices, upon initial examination, contained internal failure sites, obvious only when top metallization was removed, or in cross-section. Figure 4-9 and Figure 4-10 present such a case. Here, an internal failure site beneath the top contact metallization is shown.
